Evaluation Report

530

VICON RP 1510 Round Baler (tested as Cereal Implements 560 Round Baler)

CEREAL VICON RP1510 560 ROUND BALER

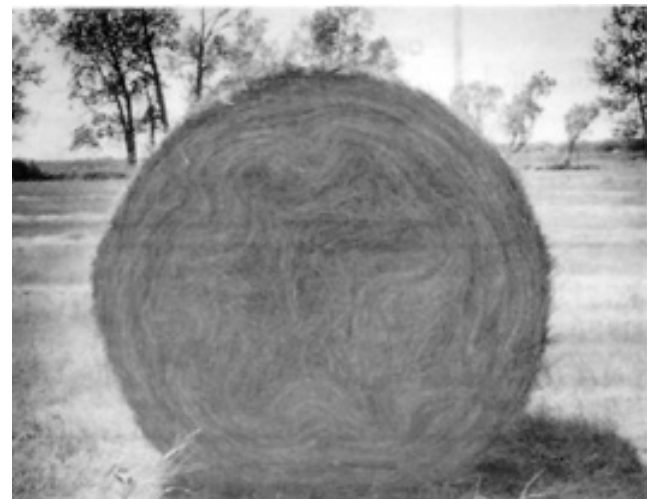
FIGURE 2. Typical Hay Bale.

Bale Quality: The RP 1510 produced firm, durable bales with flat ends and uniform diameter in all hay crops and straw crops (FIGURE 2). Handling the bales when transporting did not present a problem. The overall bale quality depended greatly on the operator experience. Failure of the operator to evenly feed both sides of the baler in light windrows resulted in barrel or cone-shaped bales.

A typical hay or straw bale averaged 5.0 ft. (1.5 m) in width and 6.0 ft. (1.8 m) in diameter. Bales usually settled to about 95% of their original height after 90 days. Average hay bales weighed from

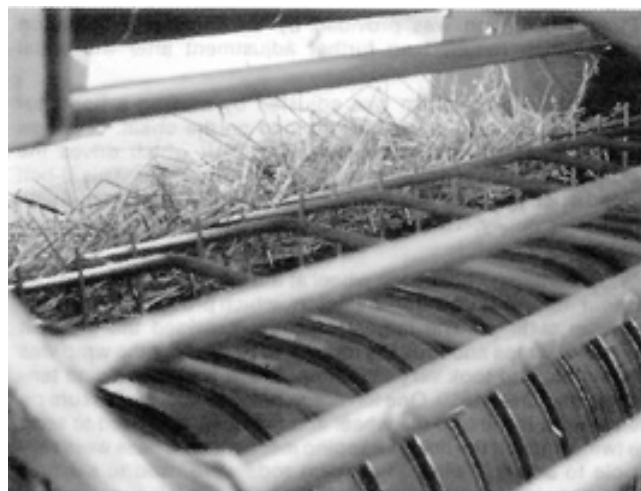
FIGURE 6. Material Caught Between Pickup and Forming Platform.

Feeding: Feeding was positive and aggressive in most crops. Plugging occurred frequently in greenfeed and occasionally in damp hay and straw. Plugging occurred due to bunching of material between the pickup and the forming platform section of the chamber. The pickup teeth had retracted at this point and the forming belts could not pull the material into the bale chamber (FIGURE 6). The operator had to stop the baler and remove the bunched material. This problem occurred mainly when the material was damp. It occurred frequently in greenfeed because of the high moisture content. It is recommended that the manufacturer consider moving the pickup closer to the forming chamber to shorten the distance between the pickup and the platform belts.

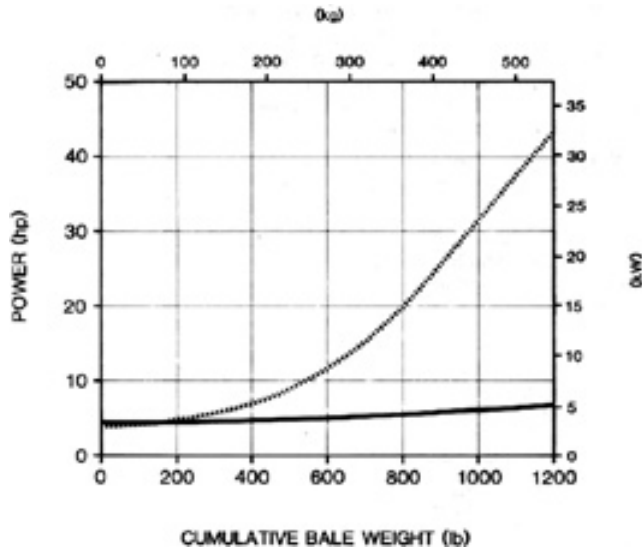
FIGURE 7. Power Consumption During Bale Formation in Alfalfa Bromegrass.

Power Requirements: FIGURE 7 shows the power take-off and drawbar power requirements for the RP 1510. The power input is plotted against bale weight to show the power requirements while a bale is formed. Power take-off requirements varied from 4.0 hp (3.0 kW) at no load to a maximum of 43 hp (32.5 kW) in alfalfa. Drawbar requirements at 6.6 mph (10.6 km/h) on flat firm fields were about 4.0 hp (3.0 kW) when the bale reached maximum size. Although maximum horsepower requirements did not exceed 47 hp (35 kW) additional power was needed to suit field conditions, especially in soft hilly fields. The manufacturer suggested a 70 hp (52 kW) tractor to fully utilize baler capacity.
